# CTUIR Grande Ronde Subbasin Restoration Project

A Columbia Basin Fish Habitat Enhancement Project

## REPORT OF PROJECT PROGRESS 2002-2003

**PROJECT #1996-083-00**  
**Contract #00006229**

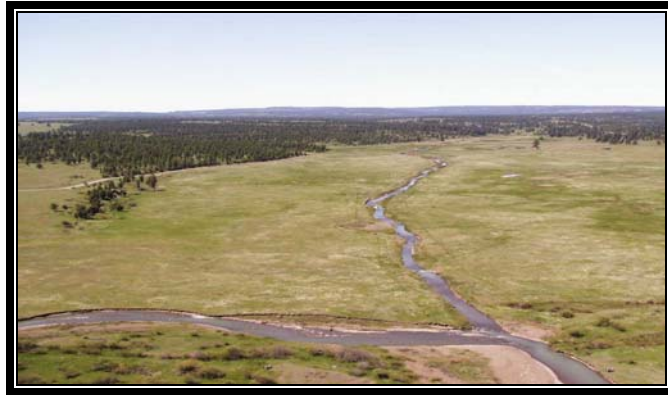
Lower McCoy Meadows at confluence of McCoy Creek and Meadow Creek (Pre-project channelized condition, May 1998)

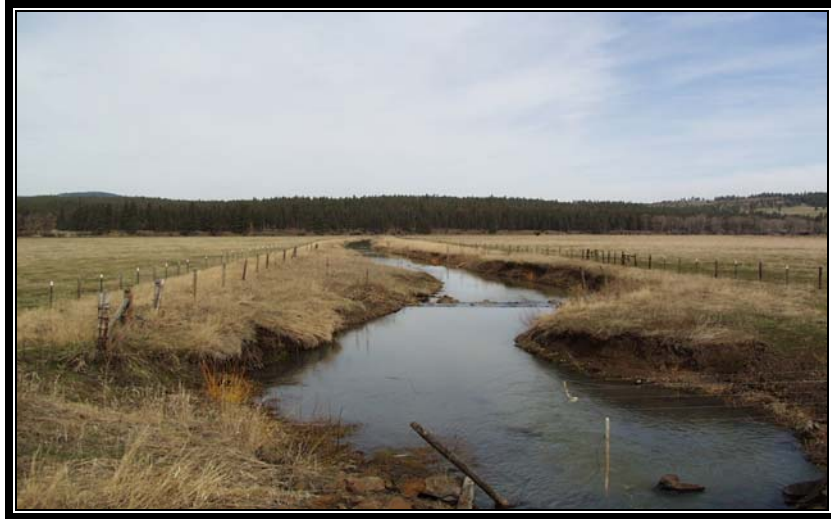
*Longley Meadows Restoration Project, Lower Bear Creek (Pre-Project channelized condition, March 1999)*

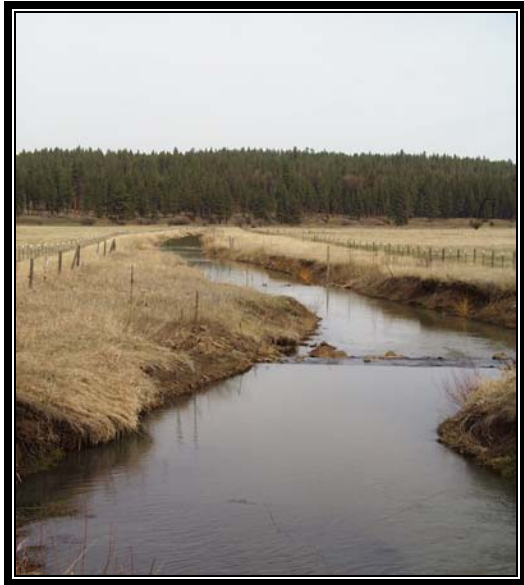
*Lower Bear Creek (Channelized Reach) viewing north, downstream from State Highway 244. March 1999.*

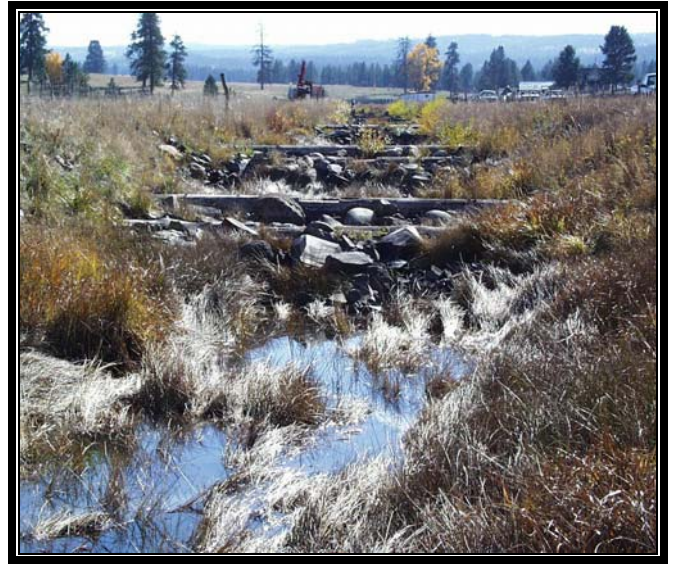
*Lower Bear Creek viewing south, upstream. Photo illustrates summer baseflow conditions and lack of fish passage created by log weir structure October 1999.*

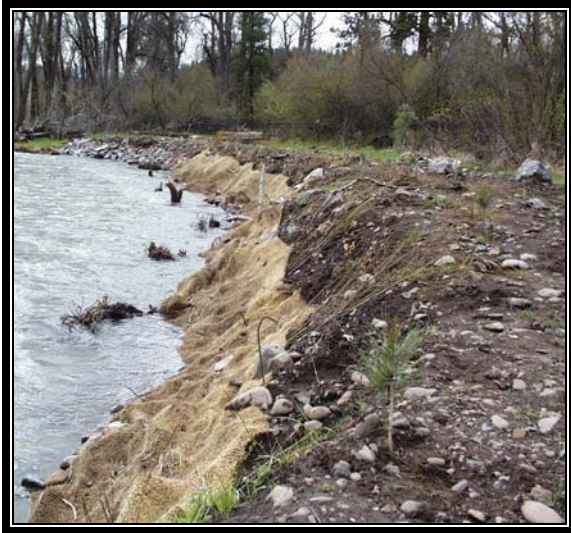
*Mainstem GR Phase I Photo Point (Oct 99'). Streambank stabilization using rootwad revetments and bioengineering to meet landowner streambank stabilization objectives.*

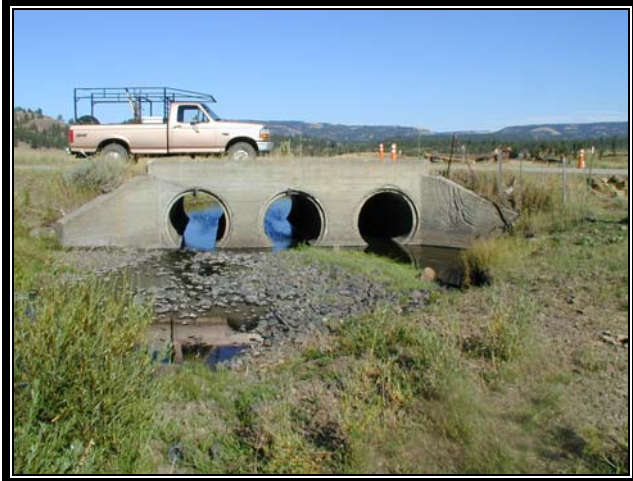
*Pre-project triple culvert on McIntyre Road. Existing structure was severely undersized for McCoy Creek.*

In addition to restoration channel construction and reclamation activities in the phase 1 reach, project partners also completed designs and installation of a new bridge on the McIntyre Road to replace an existing, undersized culvert. The new bridge consisted of a 60 foot, pre-cast concrete structure, designed to accommodate a 50 year flood flow and compliment the restoration project. Bridge construction was initiated in late 2001 and completed in October 2002. Bridge design, installation, and construction inspection was organized and coordinated by Ducks Unlimited through a cooperative agreement with the CTUIR.

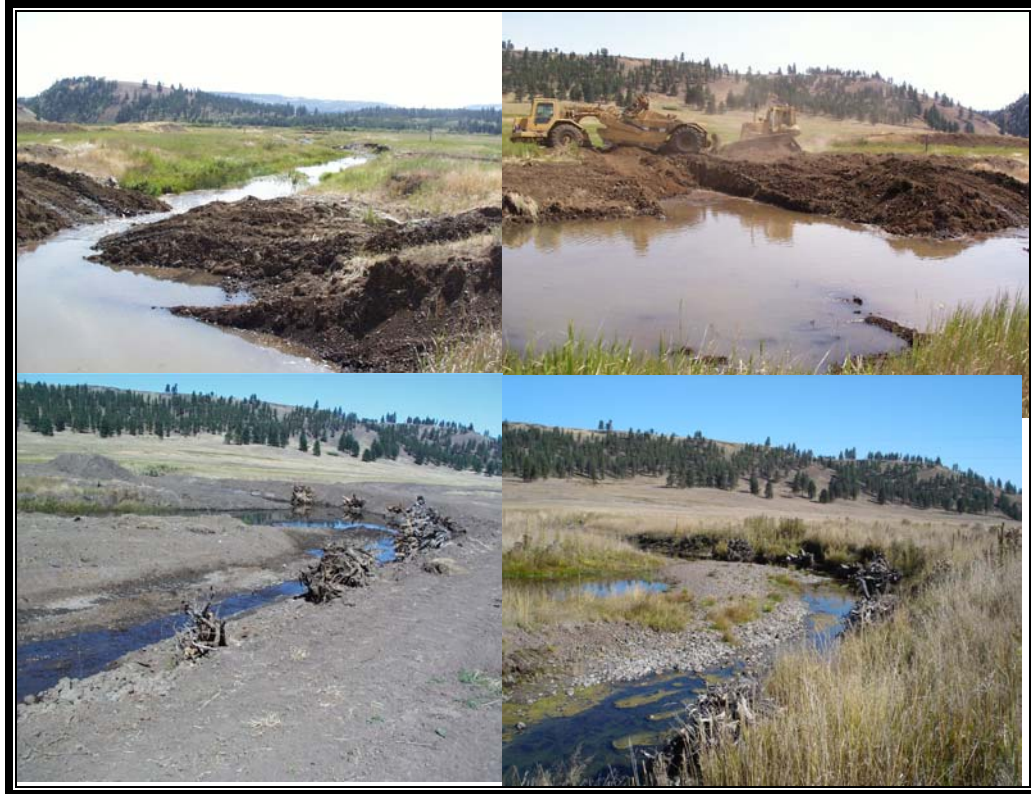
*Photo sequence taken illustrates lower channel diversion in phase 3 project reach. Upper photos show initial channel diversion efforts. Lower photos show the constructed outside meander with rootwad revetments and revegetation activities. Note vegetative recovery in lower right photo following installation of shrubs and sedge/rush mats.*

**Phase 3 McCoy Meadow Project Completion (2002-2003):** On July 1, 2002, project sponsors initiated construction of the final phases of project. Phase 3 included completing restoration channel construction, fish trap and haul/salvage prior to channel diversion, channel diversion, and reclamation the existing channelized reaches. Restoration channel construction consisted excavating an additional 800 feet of channel to connect channel segments constructed in 2001. In conjunction with the channel excavation, approximately 400 feet of rootwad revetment structures were installed along two segments where the restoration crossed the existing channel (one in the upper meadow and one in the lower meadow). Channel reclamation consisted of constructing compacted earthen plug structures in the channelized reach and contouring/shaping slopes to develop a network of floodplain ponds. An estimated 15,000 cubic yards of material excavated from the new channel was utilized to create the compacted plugs and fill about 40% of the channelized reach. Additional channel swale construction was accomplished to interconnect the floodplain pond network.

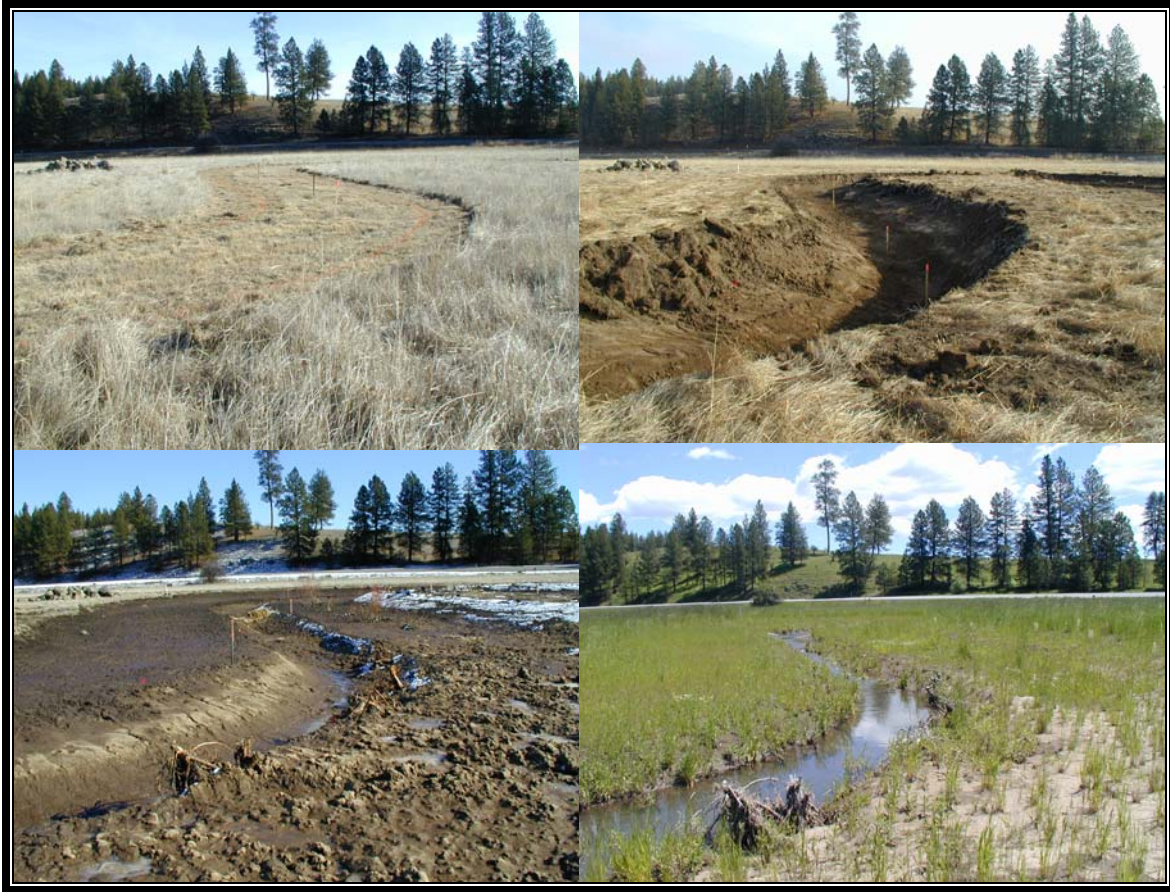
*Lower Bear Creek photo sequence taken by ODFW illustrating pre-project 2002, during project, and post project (2003). Note vegetation establishment is just getting underway with one growing season. Initial planting efforts including seeding and installation of sedge/rush plugs and livewhip willow*

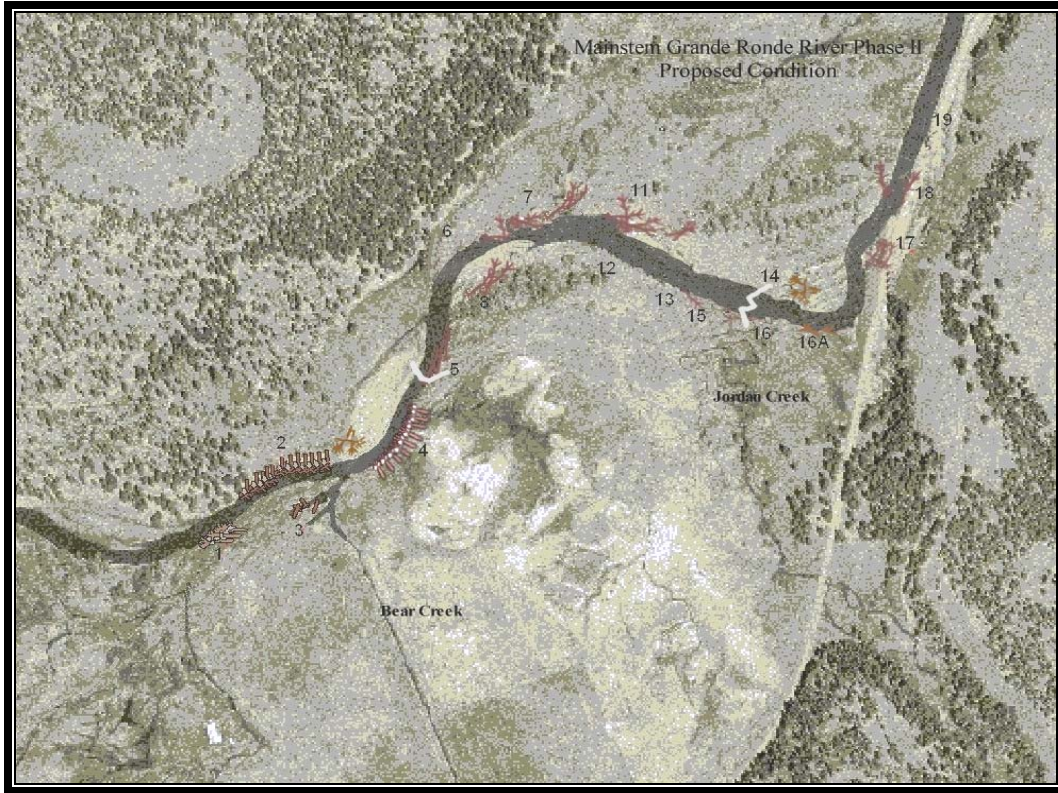
**FIGURE 24 PHASE 2 MAINSTEM GRANDE RONDE RIVER HABITAT ENHANCEMENT PROJECT**

*Mainstem Grande Ronde Project – modified aerial photograph of proposed project actions. Structure sites are numbered and correspond with the attached action plan. Note: Photo does not show project modifications to Bear Creek.*

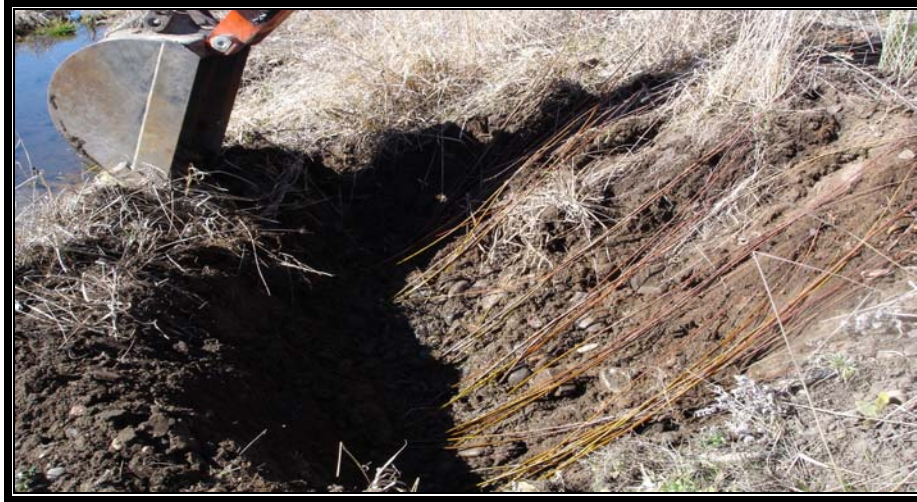
*Mainstem Grande Ronde River – Shrub planting included mechanical installation of bundled, conditioned live willow whips. Strategy includes deep installation of material near water sources to facilitate recovery.*

Following completion of construction activities, initial revegetation actions were implemented including broadcast seeding with native/native-like seed mix, mechanical live willow whip installations, mechanical planting of 2-year old bareroot willow stock (outgrown at the CTUIR Native Plant nursery), and manual installation of containerized gallon shrub stock (dogwood, willow, and cottonwood) secured through a private vendor.

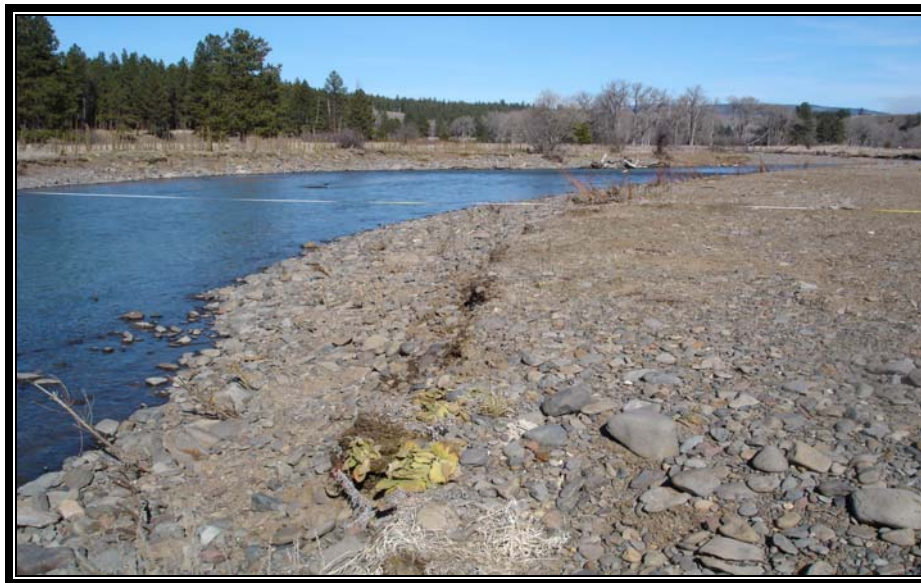
*Photo illustrates gravel bar planting using technique described above. In addition to conditioned livewhip, bareroot stock is also mechanically planted. Materials for the project were grown-out at CTUIR Native Plant Nursery.*

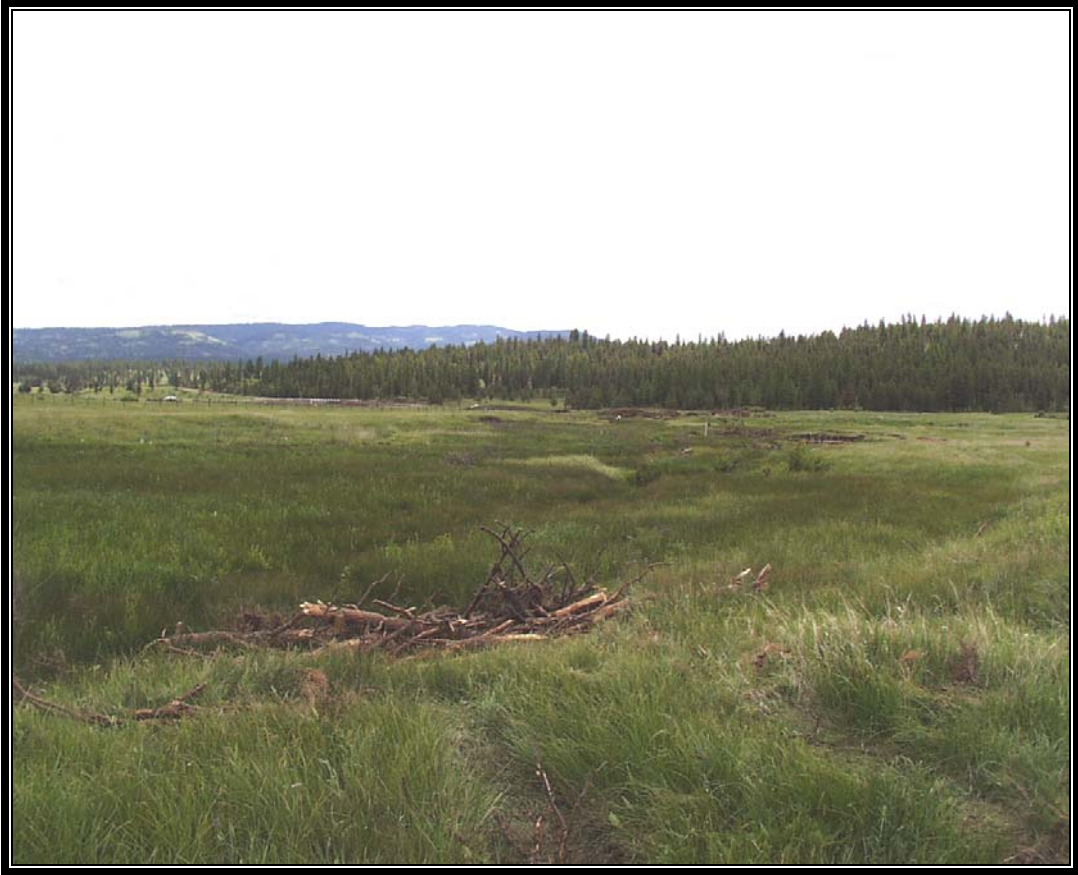
**McCoy Meadows 6/02, Photo Point A12-24 (Reclamation activities along pre-project  
channelized reach. Compacted earthen plug and floodplain pond shaping)**

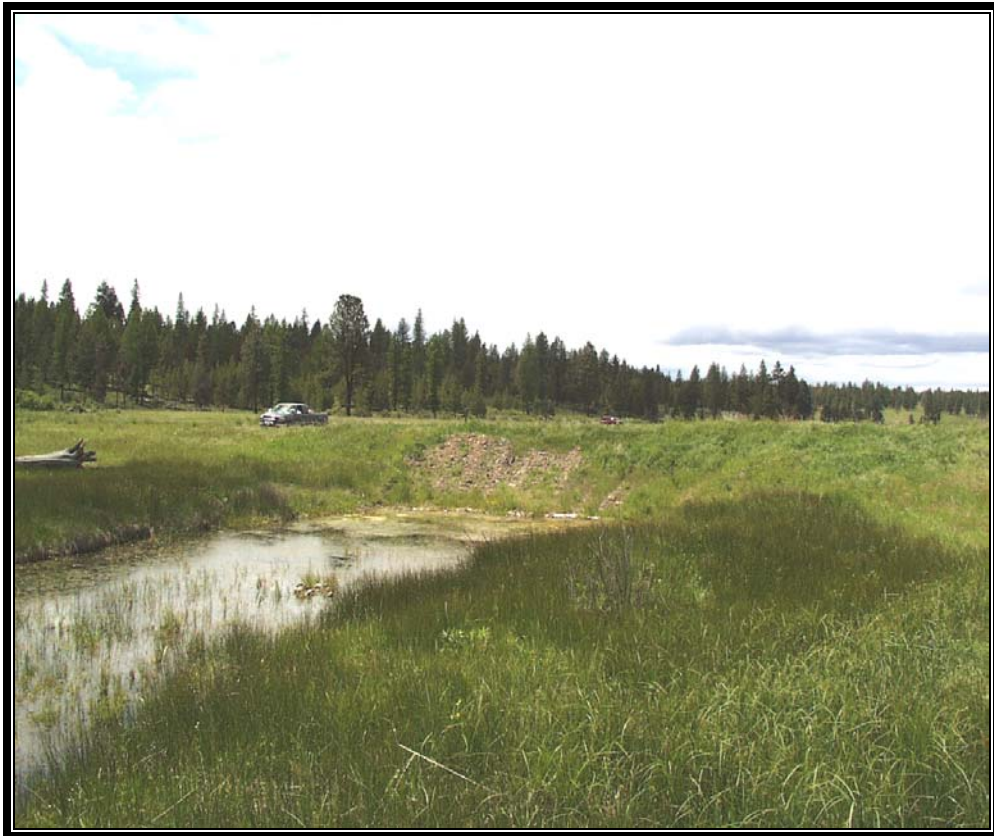
**McCoy Meadows 6/02, Photo Point A13-25  
(Floodplain pond shaping in channelized reach)**

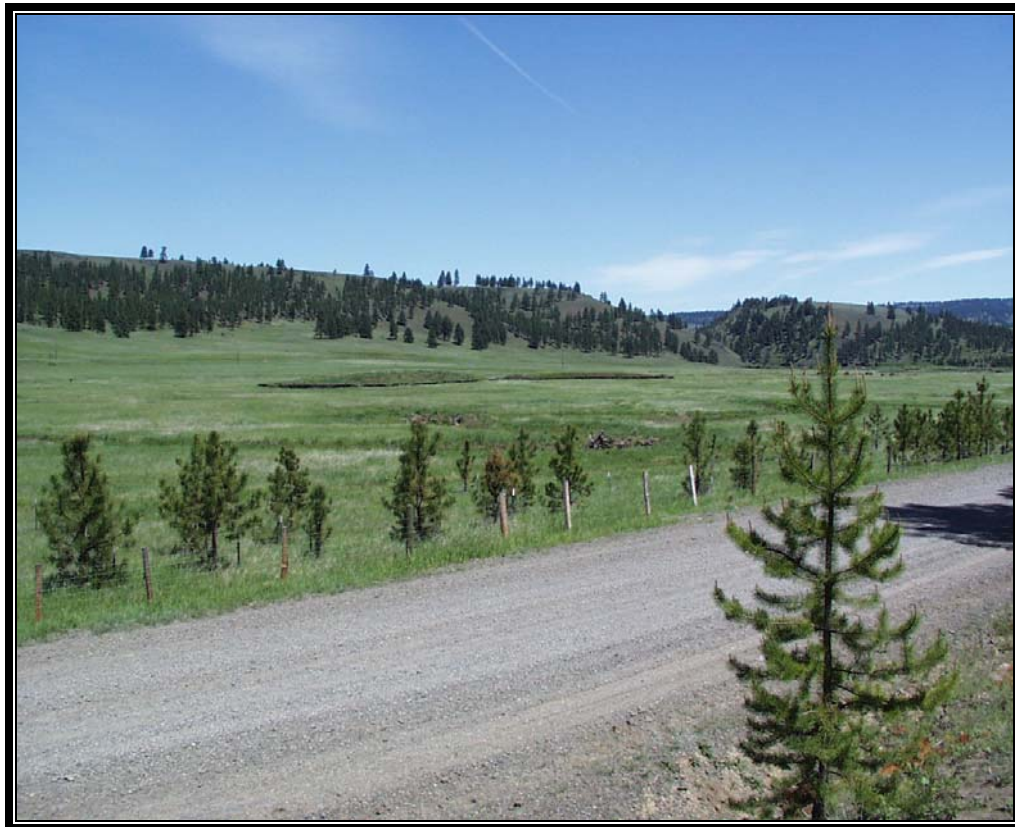
**McCoy Meadows 6/01, Photopoint A17**  
**Phase 2 channel construction and initiation of revegetation activities**

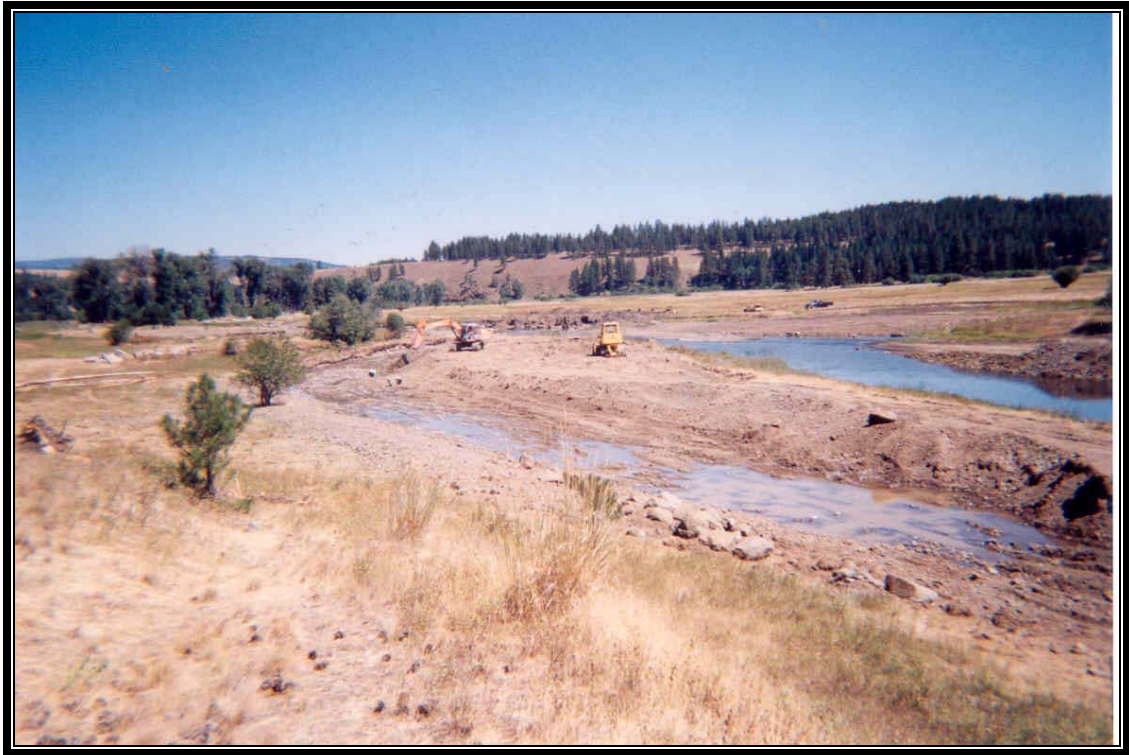
**Longley Meadows, Mainstem Grande Ronde Project, Photo Point GR-5 – photos illustrate the construction of new meander channel just upstream of Bear Creek.**
